American Home Inspections of NE NC

Property Address US Coast Guard Housing, Unit #46017

Inspector Name Ralph W. Woodard, NC Licensed Home Inspector #493
Company Name American Home Inspections of NE NC
Company Address PO Box 2347
City Kitty Hawk State NC Zip 27949
Phone Cell 25 202 8344 Fax x
E-Mail ralphdubya@embargmail.com

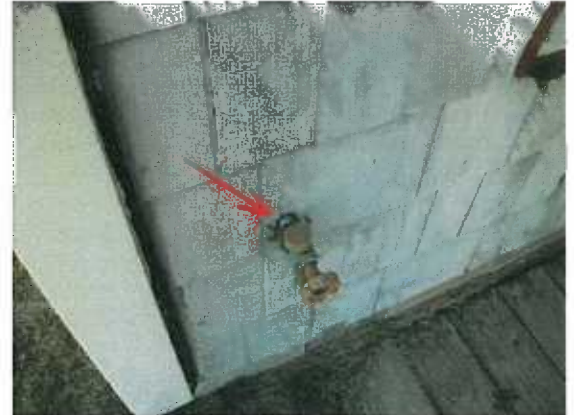
19. ☐ ☐ ☐ ☐ ☒ Hose Bibs: Frost Proof The hose bib is not properly mounted to the exterior wall.

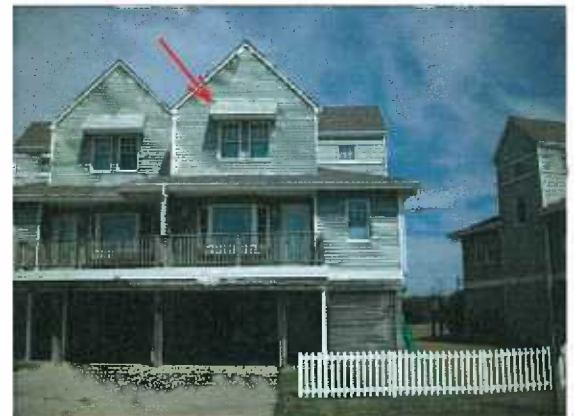
6. ☐ ☐ ☐ ☐ ☒ Wood Shake Roof: "Eye Brow" Roof above double windows There are shingles missing from the accent roof above the front double windows.

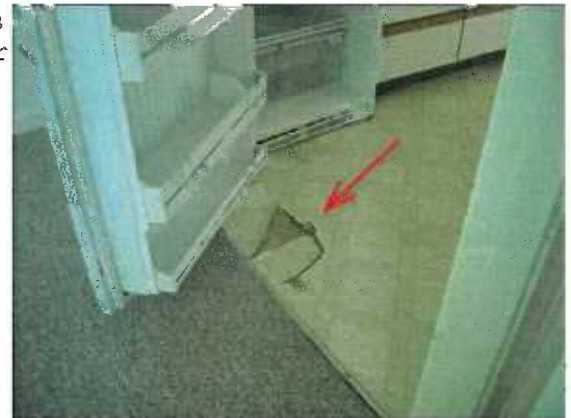
12. ☐ ☐ ☐ ☐ ☒ Floor: Vinyl floor covering The carpet is damaged in the area of the refrigerator and the vinyl seam is damaged.

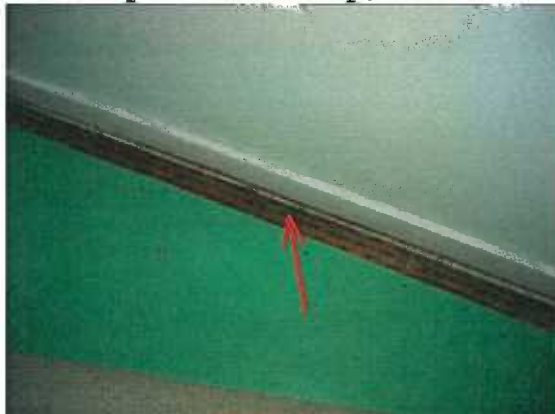
Top Rear Bedroom

1. ☐ ☐ ☐ ☐ ☒ Closet: Single There is a stain on the drywall ceiling. The carpet tack strip, the nails are rusty.

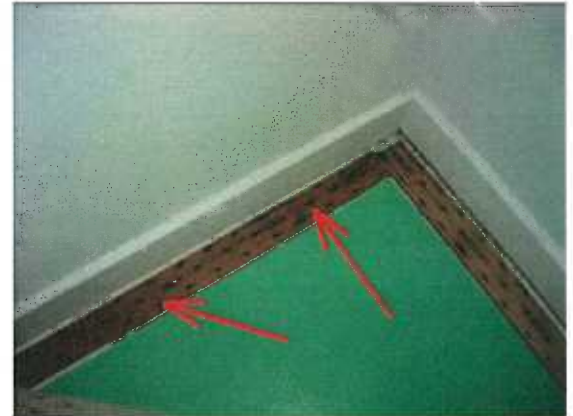
12. ☐ ☐ ☐ ☒ ☐ Floor: Carpet The nails in the carpet tack strip are rusty. This indicates that moisture was present in the past.

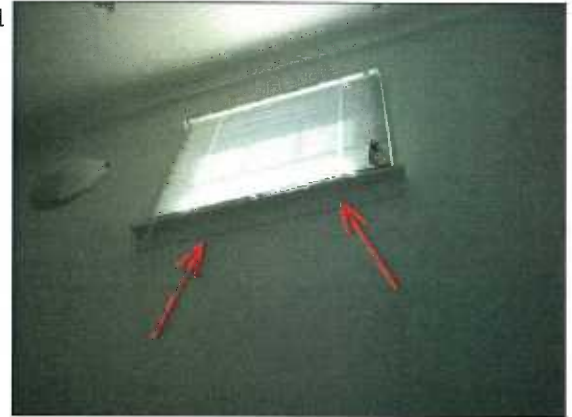
25. ☐ ☐ ☐ ☒ ☐ Windows: Andersen, Double Hung, Tilt and Wash Under the top most window, there appears to signs of moisture intrusion at the bottom of the window.

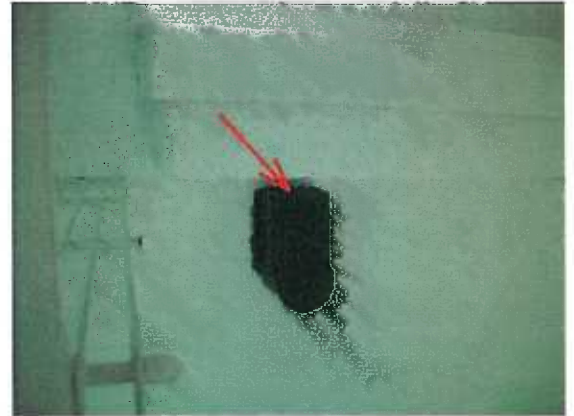
9. ☐ ☐ ☐ ☒ ☐ Washer and Dryer Electrical: 110-240 VAC The electrical receptacle for the clothes dryer does not appear to have been properly installed. There is a hole visible in this fixture.

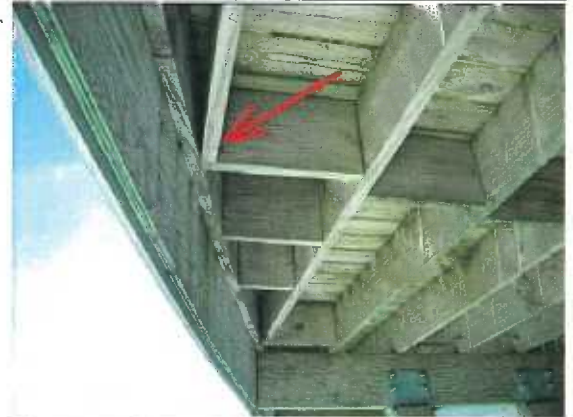
1. Deck: Front, Pressure Treated Wood There is one floor joist near the front of the deck that is not properly supported with a metal joist hanger.

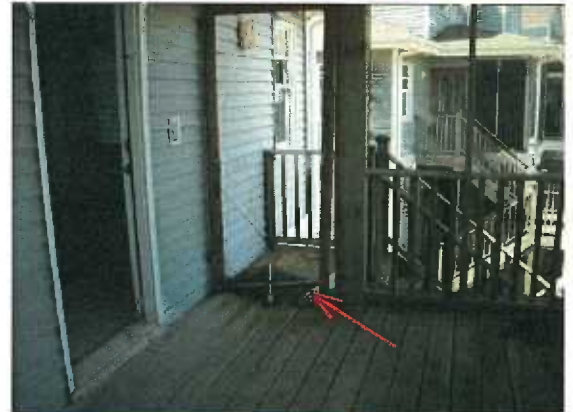
2. Porch: Rear, Pressure Treated Wood Screen panels for the porch are missing or damaged. The porch screen door is damaged.

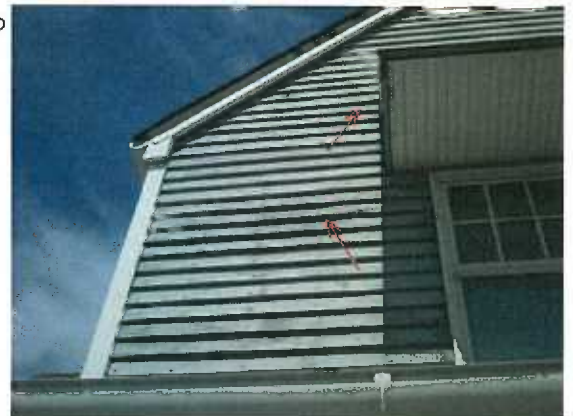
3. Exterior Walls Exterior Surface Type: Horizontal Wood Ship Lap Siding All exterior wall surfaces should be examined and re nailed in the areas where is has become loose.

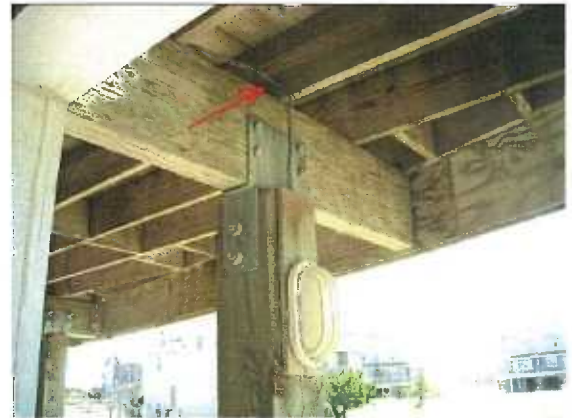
5. Exterior Lighting: Exterior, Surface Mount There is a exterior light under the front deck that was wired with underground romex wiring that should have been installed in electrical conduit. There is a light installed for the rear stairs. The underground romex wiring for this light should have been installed in electrical conduit.

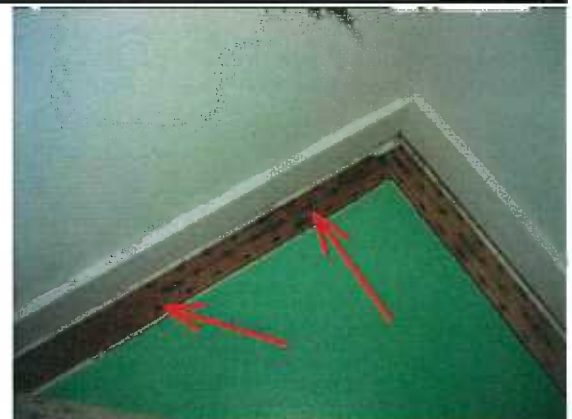
10. Top Front Bedroom Floor: Carpet The nails in the carpet tack strip are rusty. This indicates that moisture was present in the past.

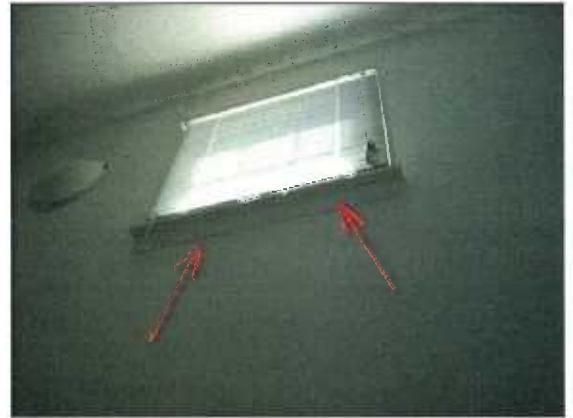
12. Stair Well Living Space Windows: Andersen, Double Hung, Tilt and Wash Under the top most window, there appears to signs of moisture intrusion at the bottom of the window.

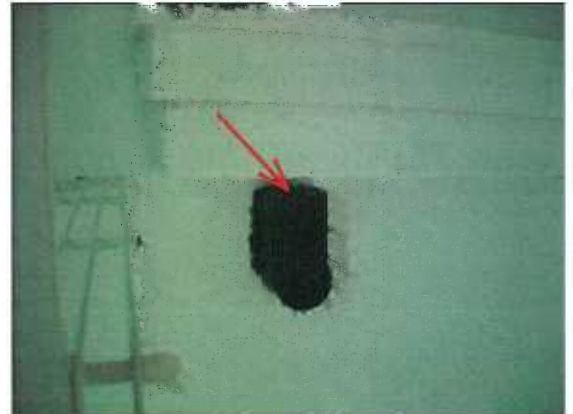
13. Main Level Laundry Room/Area Washer and Dryer Electrical: 110-240 VAC The electrical receptacle for the clothes dryer does not appear to have been properly installed. There is a hole visible in this fixture.

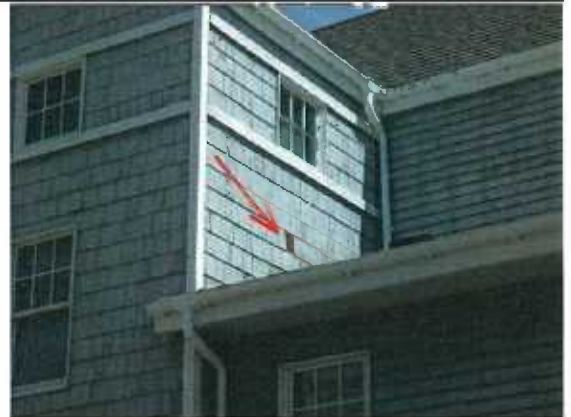
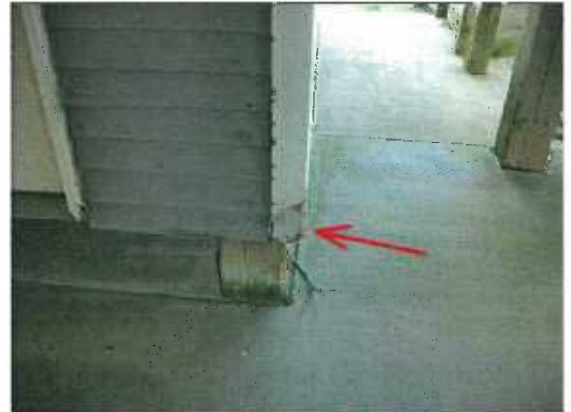
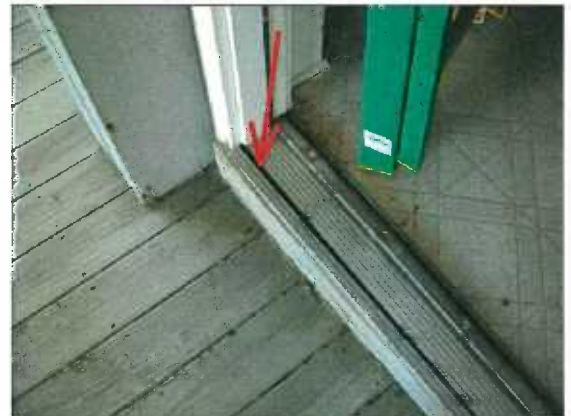
1. Accent Walls Exterior Surface Type: Plywood Panels with machine shake appearance. There is one piece of the wood shake shingle panel missing from the wall, The machine shake look plywood panels, the nails are loose in several places. The exterior walls should be examined and the loose siding re nailed. The exterior of the house should be pressure washed and repainted.
2. Trim: Wood, Aluminum Covered The aluminum covering at the lower end of the corner post in the carport is damaged.
3. Entry Doors: Ground Front, Fiberglass, Full View Glass The door threshold is made of two pieces of aluminum. The two pieces have separated.

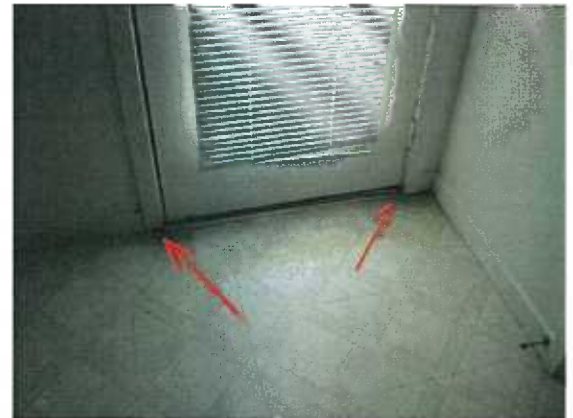
4. Entry Door: Kitchen/Dining Area, Fiberglass, Fullview Glass Moisture is migrating to the inside at the door threshold. The door and threshold need to be adjusted to stop the moisture migration. The sub floor on the inside is deteriorated and the vinyl flooring is damaged/deteriorated.

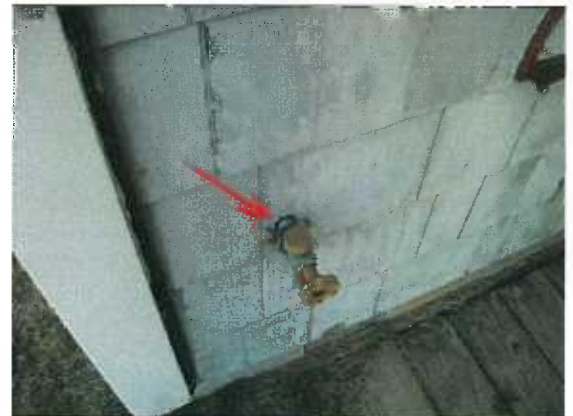
5. Hose Bibs: Frost Proof The hose bib is not properly mounted to the exterior wall.

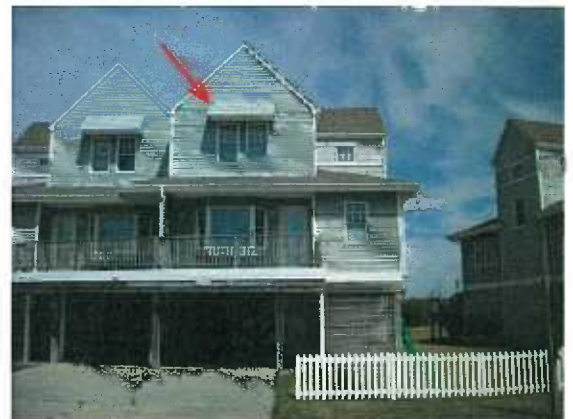
6. All Roof Areas Roof Surface Material: Asphalt shingle There is one 3'X5' area of shingles that are missing.
7. Wood Shake Roof: "Eye Brow" Roof above double windows There are shingles missing from the accent roof above the front double windows.

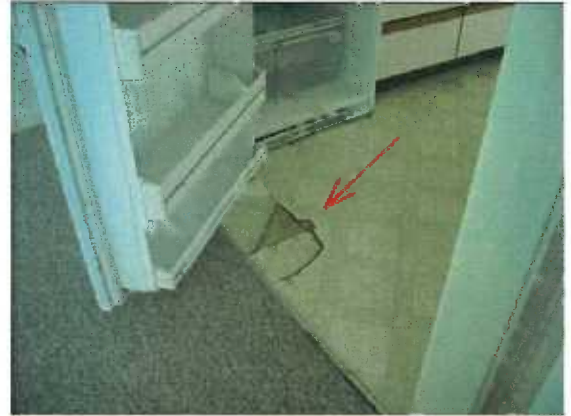
12. Kitchen & Dining Area, Main Level Kitchen Floor: Vinyl floor covering The carpet is damaged in the area of the refrigerator and the vinyl seam is damaged.

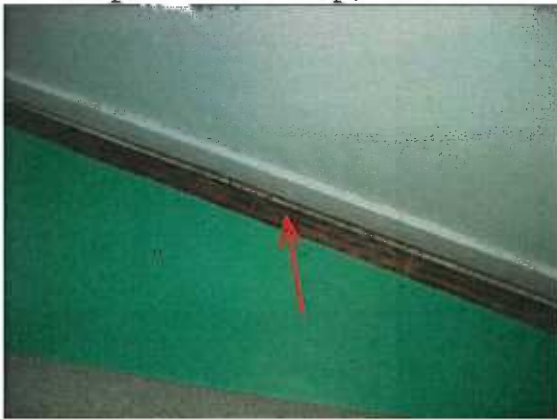
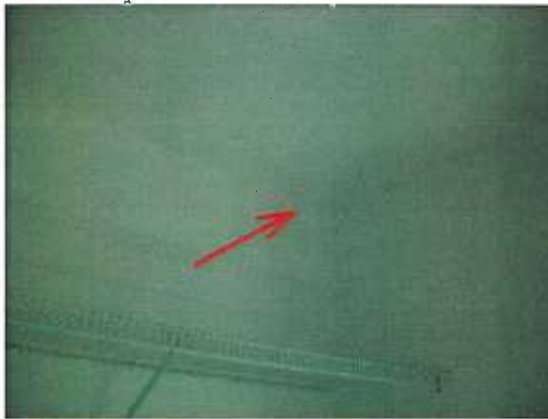
13. Top Rear Bedroom Closet: Single There is a stain on the drywall ceiling. The carpet tack strip, the nails are rusty.

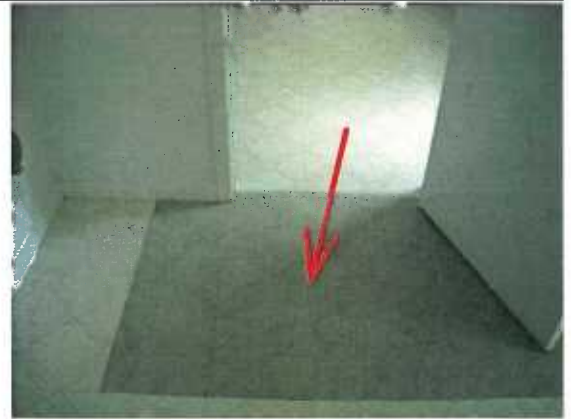
15. Main Level Laundry Room/Area Floor: Vinyl floor covering
There has been a repair made in the vinyl flooring
that does not match the existing vinyl.

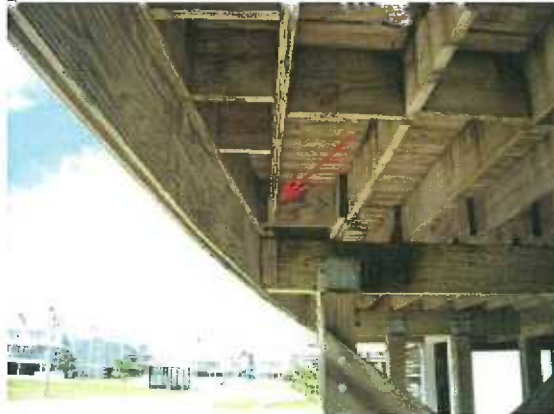
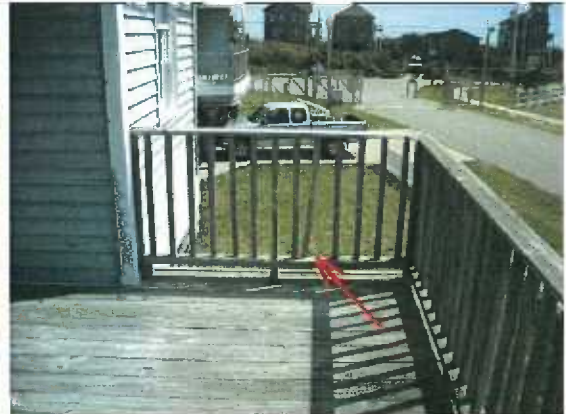
Deck: Front, Pressure Treated Wood There is one floor joist near the front of the deck that is not properly supported with a metal joist hanger. Several of the handrail pickets are loose and out of place. Close inspection revealed that the nails used to fasten the pickets to the top and bottom rails are rusty and deteriorated and failing to perform their intended function.

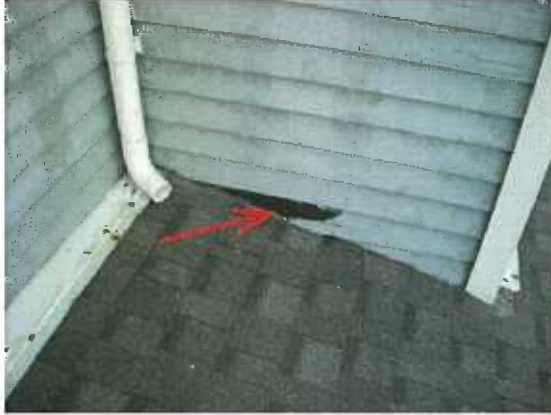
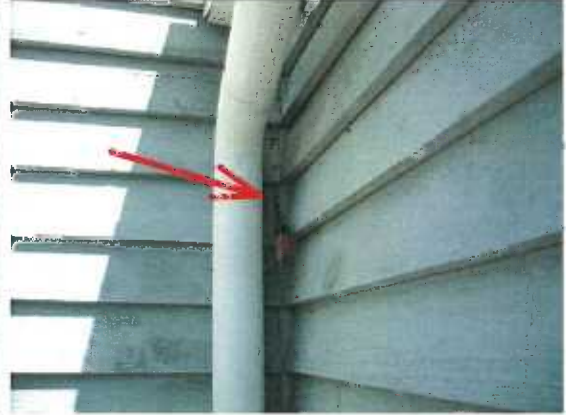
Type: Horizontal Wood Ship Lap Siding All exterior wall surfaces should be examined and re nailed in the areas where is has become loose. The exterior of the house should be pressure washed and repainted.

The siding is deteriorated at the rear where the two units are joined together.

There is a broken piece of siding at the lower part of the wall near the porch roof.

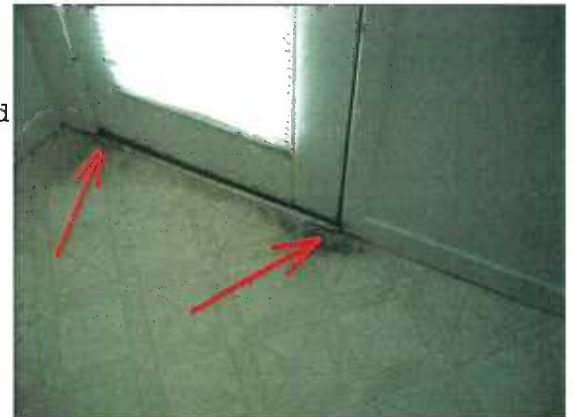
7. ☒ ☐ ☐ ☐ ☐ Type: Plywood Panels with machine shake appearance.
8. ☐ ☐ ☐ ☐ ☒ Trim: Wood, Aluminum Covered The horizontal 2X4 "beauty band" board is deteriorated.
9. ☒ ☐ ☐ ☐ ☐ Fascia: Wood, wrapped with Aluminum Coil Stock
10. ☒ ☐ ☐ ☐ ☐ Soffits: Vinyl panels
11. ☒ ☐ ☐ ☐ ☐ Entry Doors: Ground Front, Fiberglass, Full View Glass
12. ☐ ☐ ☐ ☒ ☐ Entry Door: Ground Utility Room, Fiberglass, Flush Solid Core The door hardware is possibly defective or needs cleaning and lubricating.
13. ☒ ☐ ☐ ☐ ☐ Entry Door: Main Living Area, Fiberglass, Full View Glass
14. ☐ ☐ ☐ ☐ ☒ Entry Door: Kitchen/Dining Area, Fiberglass, Fullview Glass Moisture is migrating to the inside at the door threshold. The door and threshold need to be adjusted to stop the moisture migration. The vinyl flooring on the interior of the door is deteriorated.

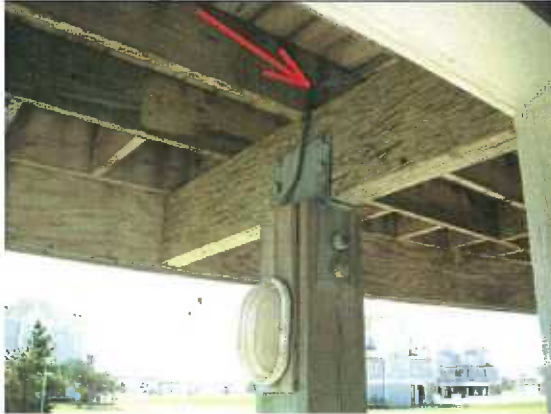
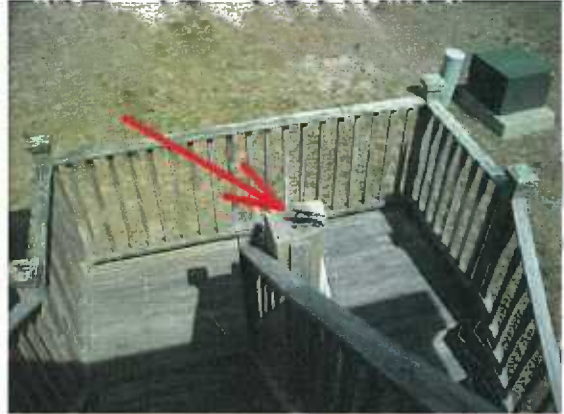
17. ☐ ☐ ☐ ☒ ☐ Exterior Lighting: Exterior, Surface Mount There is a exterior light under the front deck that was wired with underground romex wiring that should have been installed in electrical conduit. There was a light installed for the rear stairs. The underground romex wiring for this light should have been installed in electrical conduit. The electrical fixture that was installed for the rear stairs/landing is missing.

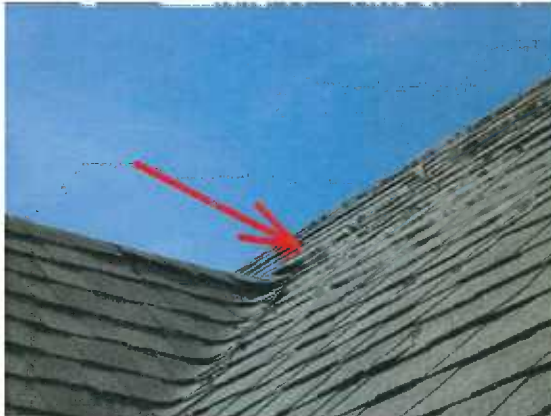
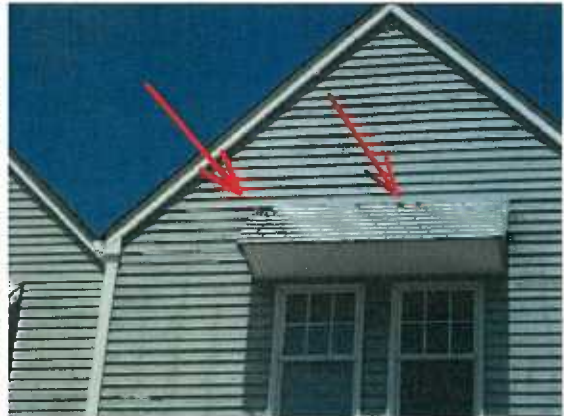
1. Method of Inspection: On roof
2. ☐ ☐ ☐ ☒ ☐ Material: Asphalt shingle There is an area of roofing missing from this roof. There are wood shingles missing from the "eye brow" roof over the double front windows.

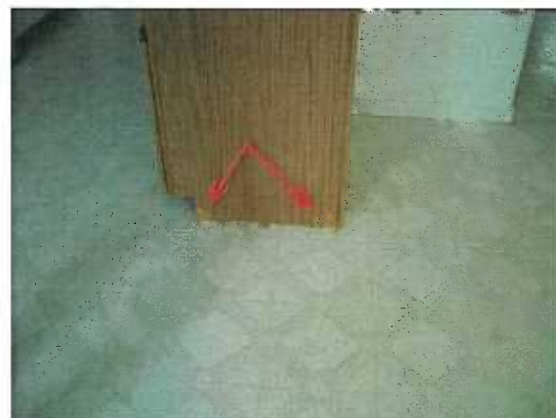
9. ☐ ☐ ☐ ☐ ☒ Cabinets: Flush Laminate The base cabinet end panel is damaged.

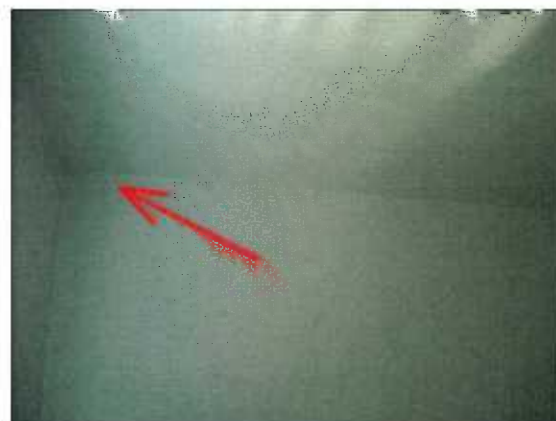
9. ☒ ☐ ☐ ☐ ☐ Closet: Single
 10. ☐ ☐ ☐ ☒ ☐ Ceiling: Drywall There is a stain in the corner of the drywall ceiling.

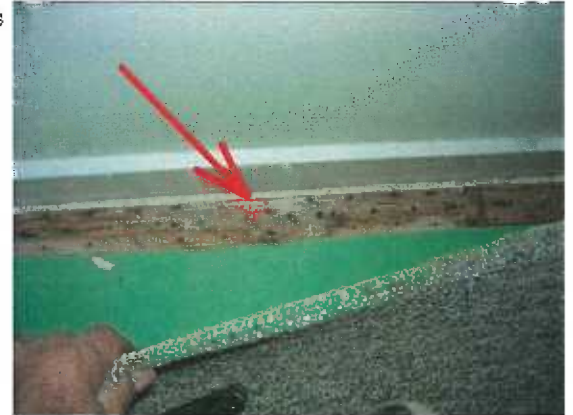
12. ☐ ☐ ☐ ☐ ☒ Floor: Carpet The carpet tack strip nails are rusty and the tack strip wood is discolored.

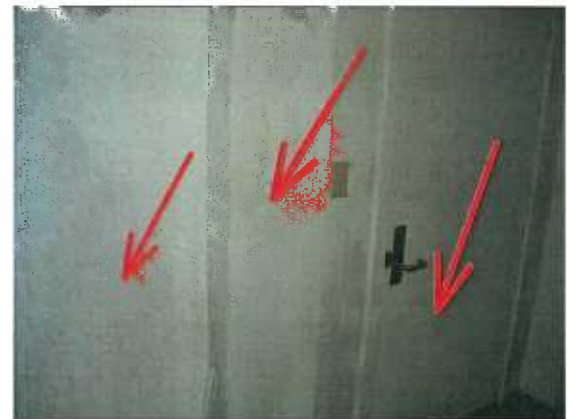
1. ☒ ☐ ☐ ☐ ☐ Ceiling: Drywall
2. ☐ ☐ ☐ ☒ ☐ Walls: Paneling, Painted There is presence of organic growth on the painted plywood walls of this room.

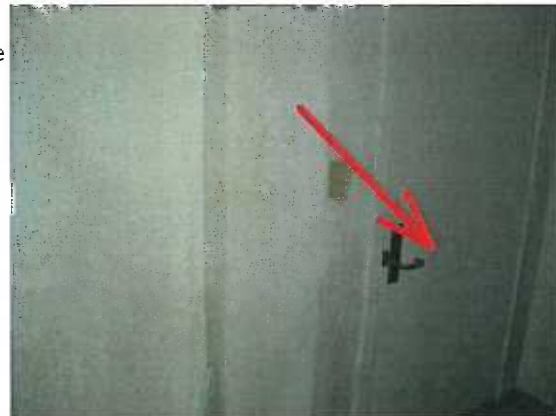
4. ☐ ☐ ☐ ☒ ☐ Doors: Painted, Flush Solid Core There is organic growth on the surface of the door.

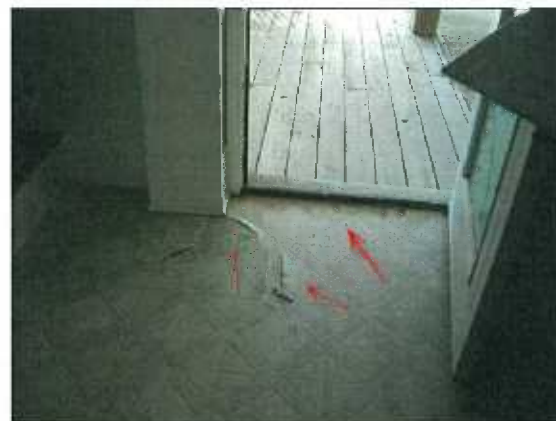
15. ☐ ☐ ☐ ☒ ☐ Closet: Single The closet door needs to be adjusted to fit into opening properly.
16. ☒ ☐ ☐ ☐ ☐ Ceiling: Drywall
17. ☒ ☐ ☐ ☐ ☐ Walls: Drywall
18. ☐ ☐ ☐ ☐ ☒ Floor: Vinyl floor covering The vinyl flooring is scuffed, burn mark and torn.

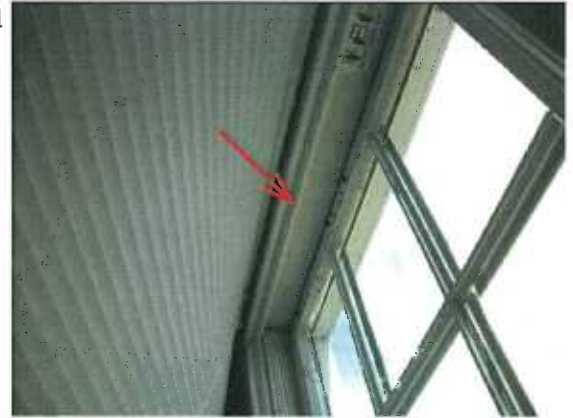
25. ☐ ☐ ☐ ☒ ☐ Windows: Andersen, Double Hung, Tilt and Wash On the window frame vinyl header, there is a stain.

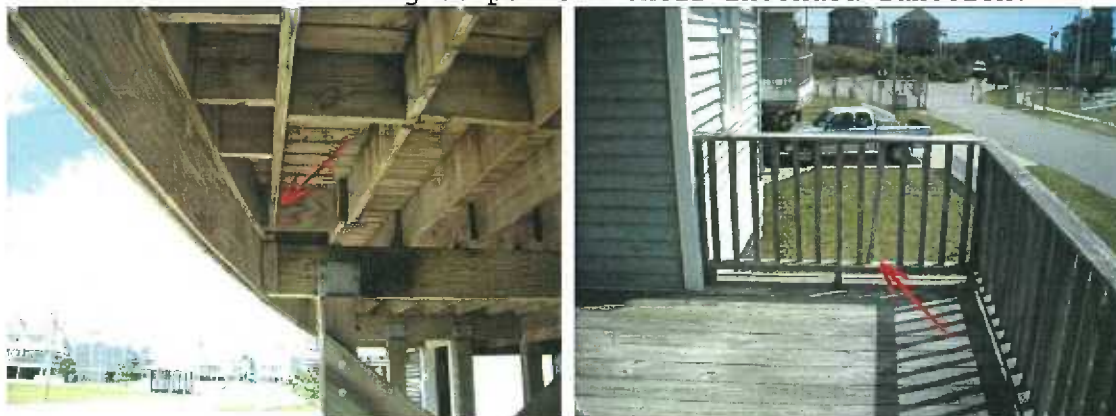
1. **Deck: Front, Pressure Treated Wood** There is one floor joist near the front of the deck that is not properly supported with a metal joist hanger. Several of the handrail pickets are loose and out of place. Close inspection revealed that the nails used to fasten the pickets to the top and bottom rails are rusty and deteriorated and failing to perform their intended function.

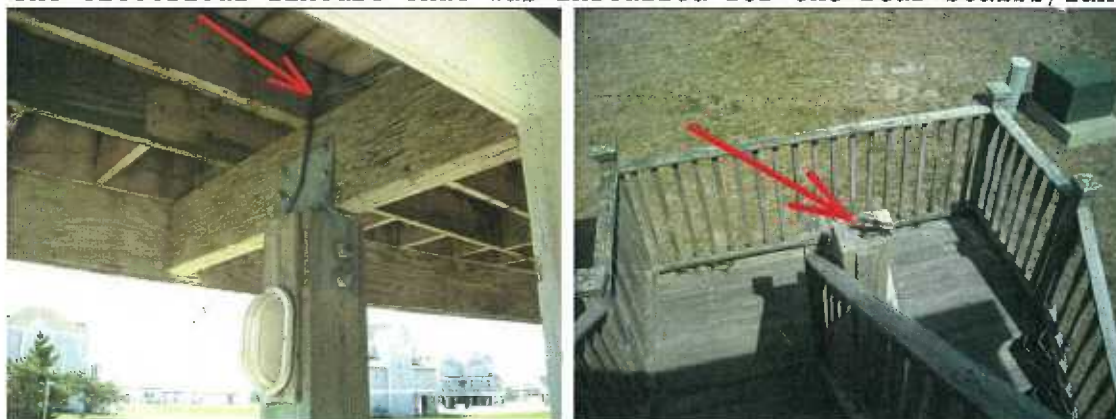
5. **Exterior Lighting: Exterior, Surface Mount** There is a exterior light under the front deck that was wired with underground romex wiring that should have been installed in electrical conduit. There was a light installed for the rear stairs. The underground romex wiring for this light should have been installed in electrical conduit.
The electrical fixture that was installed for the rear stairs/landing is missing.

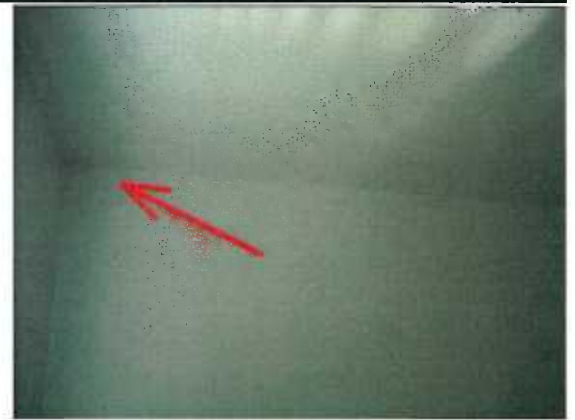
13. **Top Front Bedroom Ceiling:** Drywall There is a stain in the corner of the drywall ceiling.

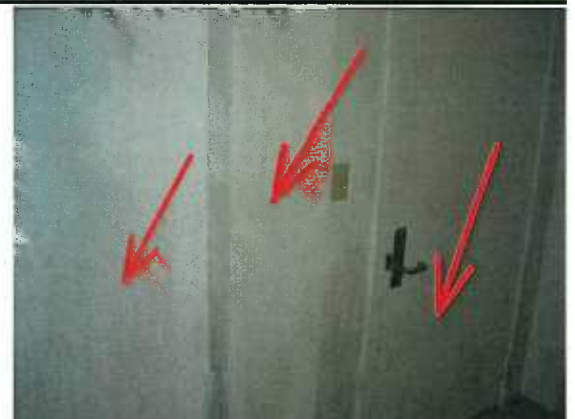
14. **Ground Level Utility/Storage Room Living Space Walls:** Paneling, Painted There is presence of organic growth on the painted plywood walls of this room.

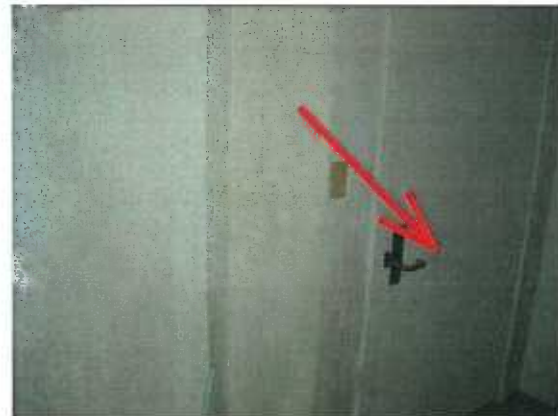
15. Ground Level Utility/Storage Room Living Space Doors: Painted, Flush Solid Core There is organic growth on the surface of the door.

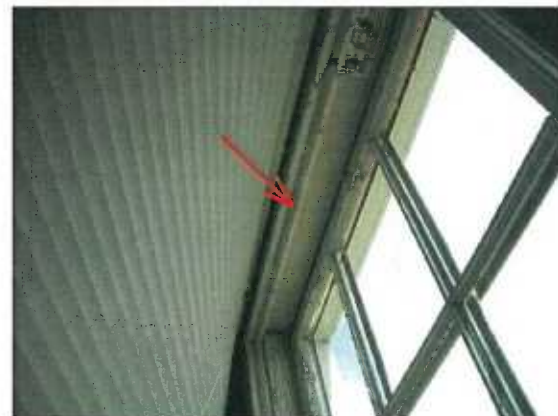
16. Ground Level Entry Living Space Closet: Single The closet door needs to be adjusted to fit into opening properly.
17. Stair Well Living Space Windows: Andersen, Double Hung, Tilt and Wash On the window frame vinyl header, there is a stain.

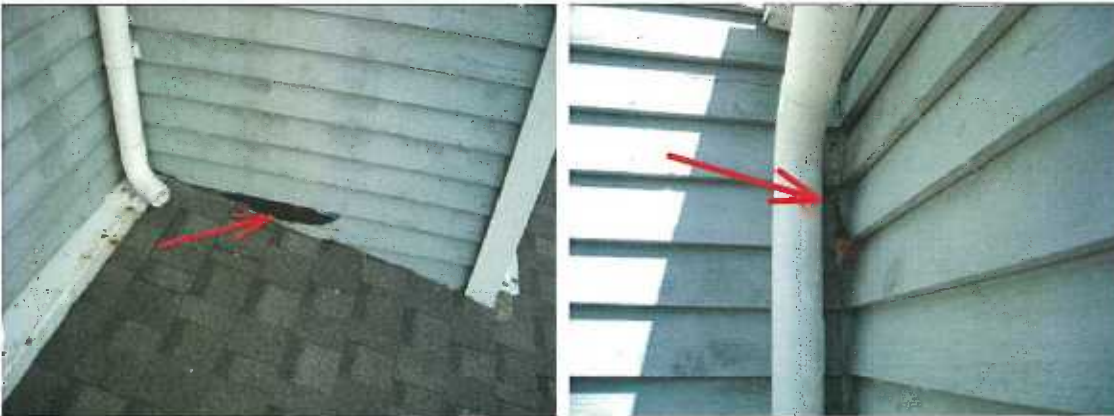
1. **Exterior Walls Exterior Surface Type:** Horizontal Wood Ship Lap Siding All exterior wall surfaces should be examined and re nailed in the areas where is has become loose. The exterior of the house should be pressure washed and repainted. The siding is deteriorated at the rear where the two units are joined together. There is a broken piece of siding at the lower part of the wall near the porch roof.

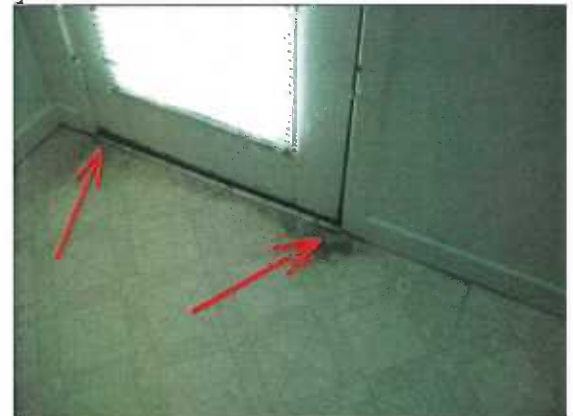
2. **Trim:** Wood, Aluminum Covered The horizontal 2X4 "beauty band" board is deteriorated.
3. **Entry Door:** Kitchen/Dining Area, Fiberglass, Fullview Glass Moisture is migrating to the inside at the door threshold. The door and threshold need to be adjusted to stop the moisture migration. The vinyl flooring on the interior of the door is deteriorated.

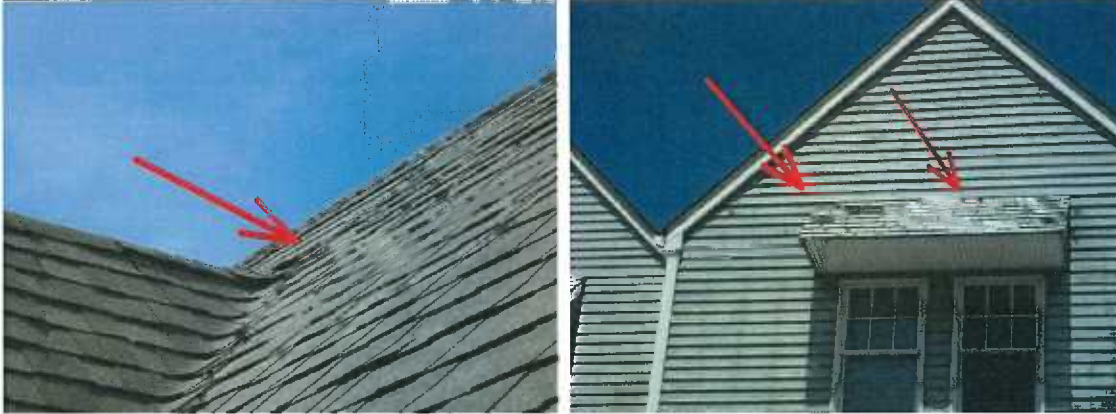
4. **All Roof Areas Roof Surface Material:** Asphalt shingle There is an area of roofing missing from this roof. There are wood shingles missing from the "eye brow" roof over the double front windows.

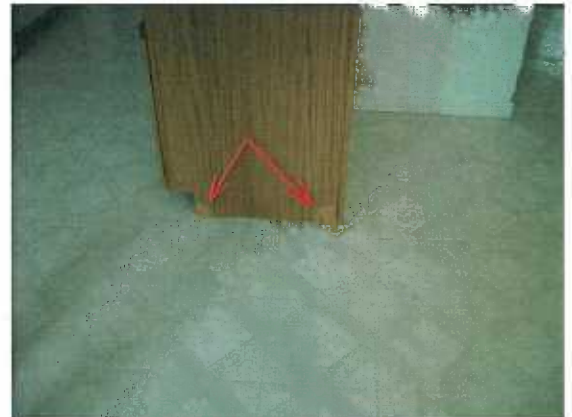
8. Kitchen & Dining Area, Main Level Kitchen Counter Tops: Laminate and composite materials Counter top laminate damaged just to the right of the sink.
9. Kitchen & Dining Area, Main Level Kitchen Cabinets: Flush Laminate The base cabinet end panel is damaged.

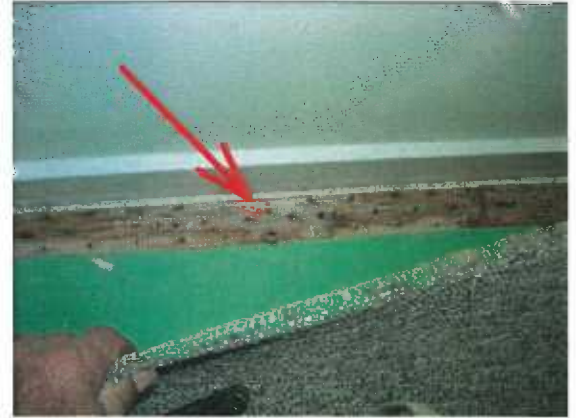
12. Top Front Bedroom Floor: Carpet The carpet tack strip nails are rusty and the tack strip wood is discolored.

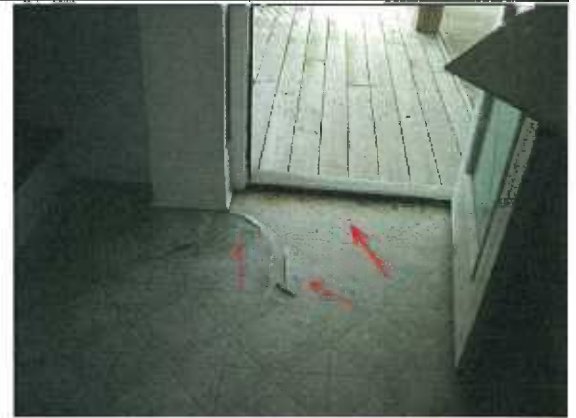
13. Ground Level Entry Living Space Floor: Vinyl floor covering The vinyl flooring is scuffed, burn mark and torn.

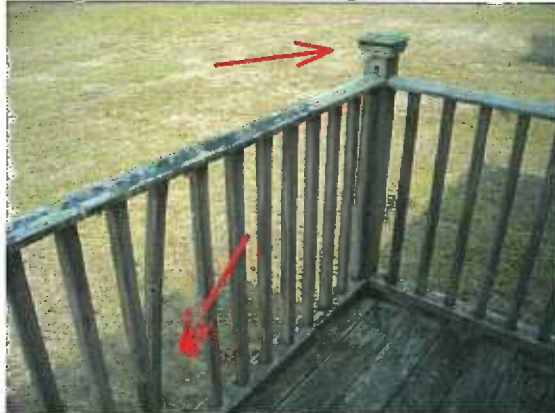
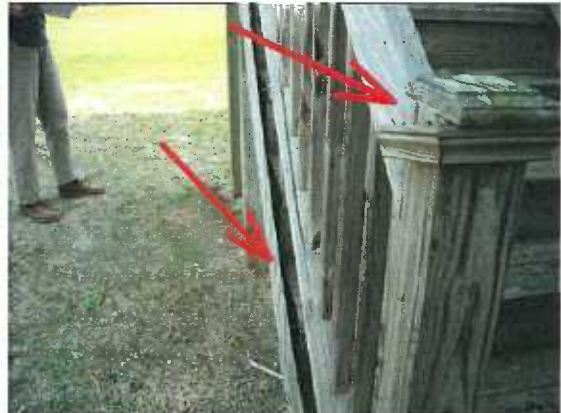
| 3. | <input type="checkbox"/> | <input type="checkbox"/> | <input type="checkbox"/> | <input type="checkbox"/> | <input checked="" type="checkbox"/> | Stairs/Landing: Rear Stairs & Landing, Pressure Treated Wood There is on trim board along the stair steps, the nails are becoming loose and the board is pulling away from the steps. The decorative wood trim at the top of the handrail post, most of this trim is missing or deteriorated. The wood pickets are loose or out of place. The nails used to secure the pickets are rusty/deteriorated. |

1. **Stairs/Landing: Rear Stairs & Landing, Pressure Treated Wood** There is on trim board along the stair steps, the nails are becoming loose and the board is pulling away from the steps. The decorative wood trim at the top of the handrail post, most of this trim is missing or deteriorated. The wood pickets are loose or out of place. The nails used to secure the pickets are rusty/deteriorated.

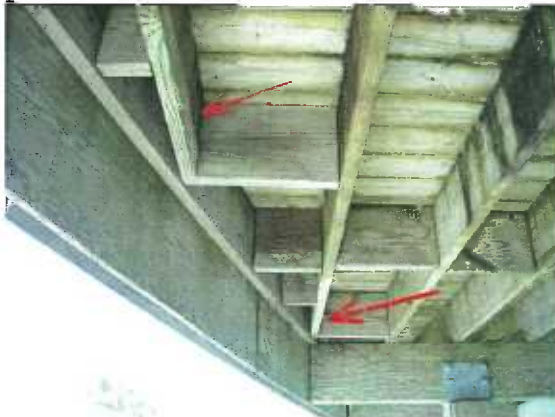
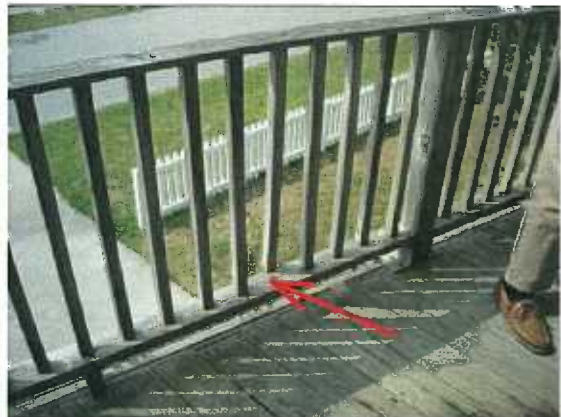
| 5. | <input type="checkbox"/> | <input type="checkbox"/> | <input type="checkbox"/> | <input type="checkbox"/> | <input checked="" type="checkbox"/> | Deck: Front, Pressure Treated Wood There is one floor joist near the front of the deck that is not properly supported with a metal joist hanger. Several of the handrail pickets are loose and out of place. Close inspection revealed that the nails used to fasten the pickets to the top and bottom rails are rusty and deteriorated and failing to perform their intended function. |

2. **Deck: Front, Pressure Treated Wood** There is one floor joist near the front of the deck that is not properly supported with a metal joist hanger. Several of the handrail pickets are loose and out of place. Close inspection revealed that the nails used to fasten the pickets to the top and bottom rails are rusty and deteriorated and failing to perform their intended function.

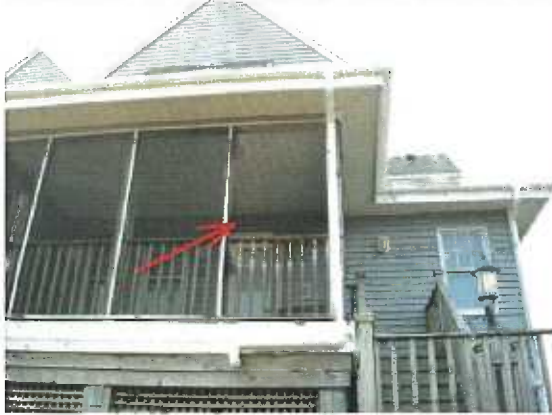
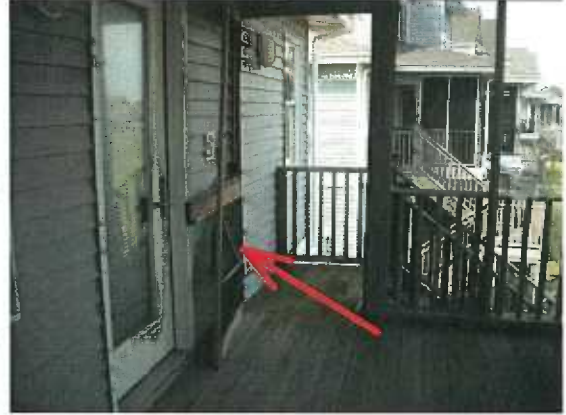
6. ☐ ☐ ☐ ☐ ☒ Porch: Rear, Pressure Treated Wood Screen panels for the porch are missing or damaged. The porch screen door is damaged.

3. **Porch: Rear, Pressure Treated Wood** Screen panels for the porch are missing or damaged. The porch screen door is damaged.

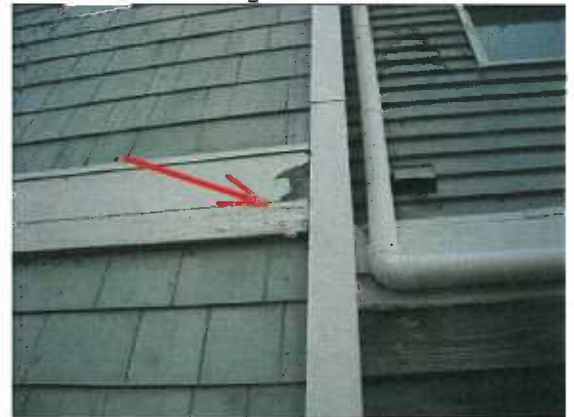
- ☒ ☐ ☐ ☐ ☐ Type: Plywood Panels with machine shake appearance. The machine shake look plywood panels, the nails are loose in several places. The exterior walls should be examined and the loose siding re nailed.
10. ☐ ☐ ☐ ☐ ☒ Trim: Wood, Aluminum Covered The bump out for the stairs, one piece of the horizontal wood trim is deteriorated.

4. Trim: Wood, Aluminum Covered The bump out for the stairs, one piece of the horizontal wood trim is deteriorated.

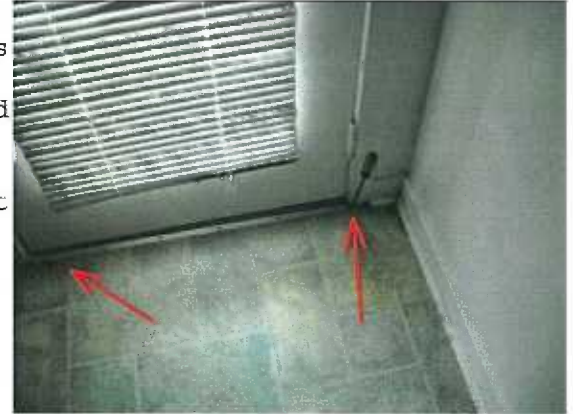
Fiberglass, Fullview Glass Moisture is migrating to the inside at the door threshold. The door and threshold need to be adjusted/replaced to stop the moisture migration. The sub floor is also deteriorated just inside of this door.

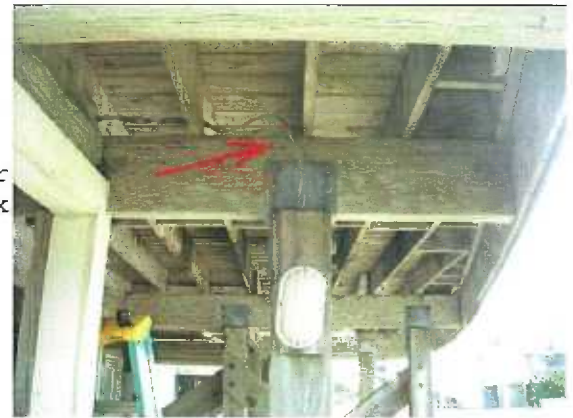
- ☐ ☐ ☐ ☐ ☒ Exterior Lighting: Exterior, Surface Mount
There is a exterior light under the front deck that was wired with underground romex wiring that should have been installed in electrical conduit. There is a light installed for the rear stairs. The underground romex wiring for this light should have been installed in electrical conduit.

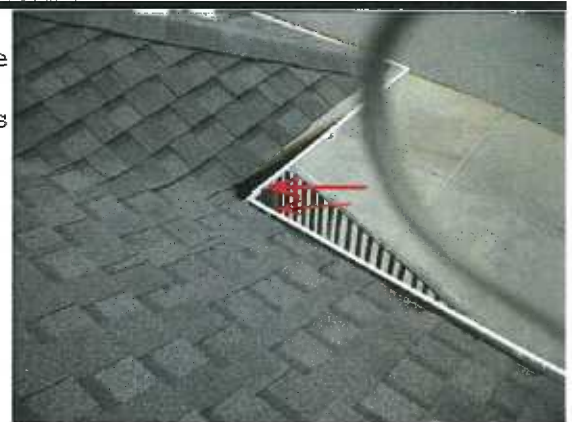
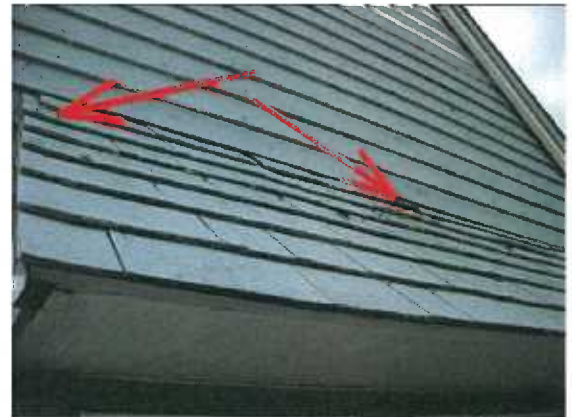
1. Method of Inspection: On roof
2. ☒ ☐ ☐ ☐ ☐ Material: Asphalt shingle
3. Type: Hip & Gable
4. Approximate Age: 14 to 16 years
5. ☒ ☐ ☐ ☐ ☐ Flashing: Metal
6. ☒ ☐ ☐ ☐ ☐ Valleys: Asphalt shingle
7. ☒ ☐ ☐ ☐ ☐ Plumbing Vents: PVC
8. Roof Water Control
9. ☐ ☐ ☐ ☐ ☒ Gutters: Plastic There is one piece of gutter pipe installed in the area above the front deck where the glue used to fasten the parts together, the glue has failed.
10. ☒ ☐ ☐ ☐ ☐ Downspouts: Plastic
11. ☐ ☐ ☐ ☐ ☒ Wood Shake Roof: Wood Shake "Eye Brow" Roof There are shingles missing from the small roof above the double windows.

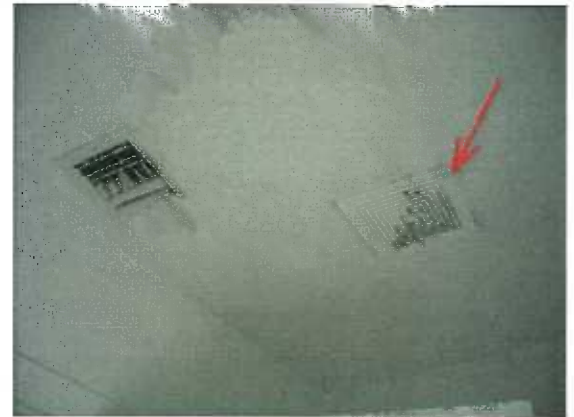
| 1. | <input type="checkbox"/> | <input type="checkbox"/> | <input type="checkbox"/> | <input checked="" type="checkbox"/> | <input type="checkbox"/> | <input type="checkbox"/> | <input type="checkbox"/> | Ceiling: Drywall There is organic growth on the ceiling drywall. |

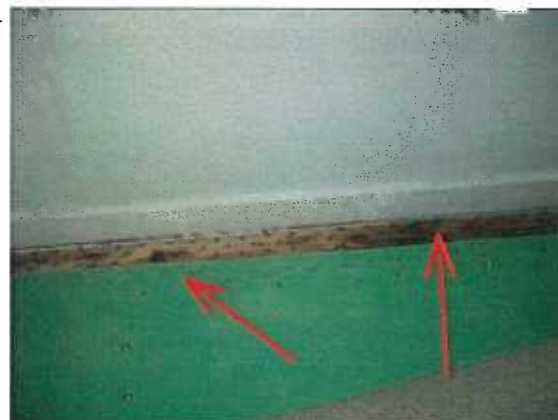
1. ☒ ☐ ☐ ☐ ☐ Closet: Single
2. ☒ ☐ ☐ ☐ ☐ Ceiling: Drywall
3. ☒ ☐ ☐ ☐ ☐ Walls: Drywall
4. ☐ ☐ ☐ ☐ ☒ Floor: Carpet The carpet tack strip along the unit party wall, the strip is stained and the tacks are rusty.

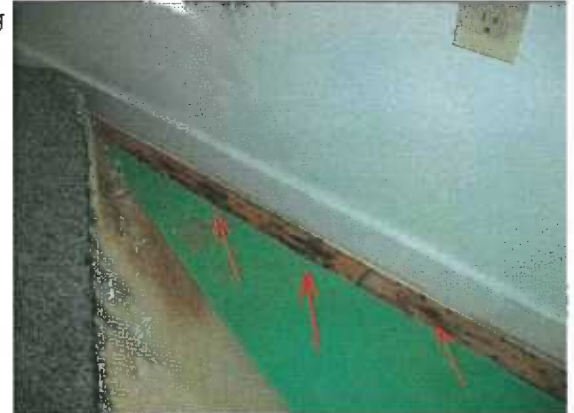
| 12. | <input type="checkbox"/> | <input type="checkbox"/> | <input type="checkbox"/> | <input type="checkbox"/> | <input checked="" type="checkbox"/> | Floor: Carpet The carpet tack strip along the unit party wall, the strip is stained and the tacks are rusty. |

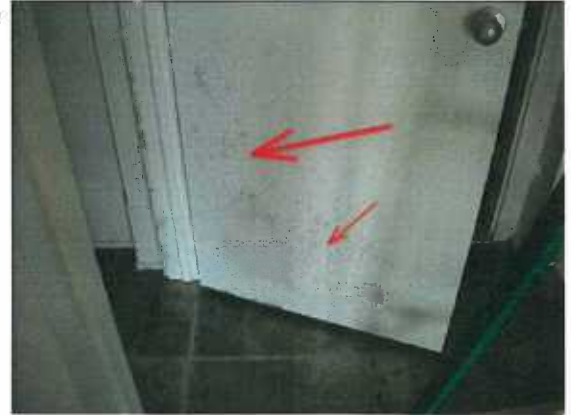
15. ☐ ☐ ☐ ☒ ☐ Closet: Single There are signs of organic growth on the closet door.

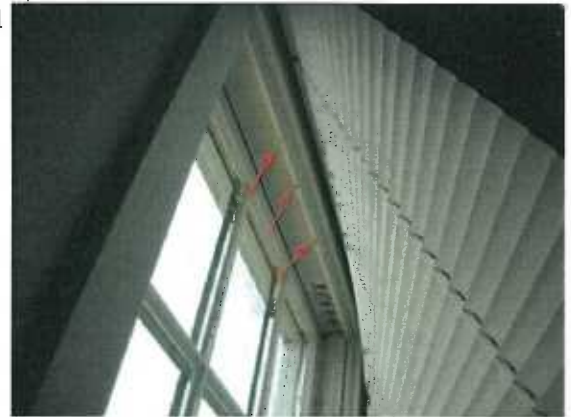
22. ☒ ☐ ☐ ☐ ☐ Ceiling: Drywall
23. ☒ ☐ ☐ ☐ ☐ Walls: Drywall
24. ☒ ☐ ☐ ☐ ☐ Floor: Carpet
25. ☐ ☐ ☐ ☒ ☐ Windows: Andersen, Double Hung, Tilt and Wash The center window in the stairwell, There are stains on the header piece of vinyl.

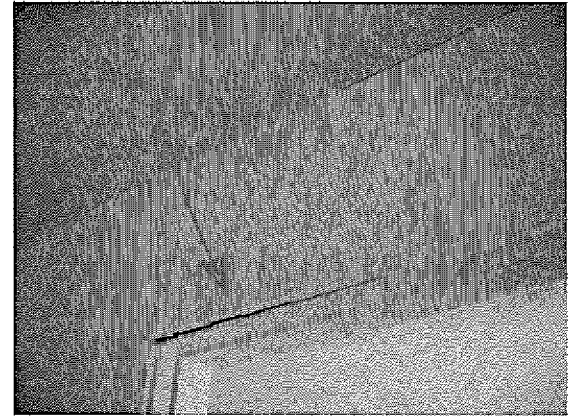
| 4. | <input type="checkbox"/> | <input type="checkbox"/> | <input type="checkbox"/> | <input checked="" type="checkbox"/> | <input type="checkbox"/> | Doors: Painted, Flush Solid Core The door trim has become loose on the inside of the laundry room door. |

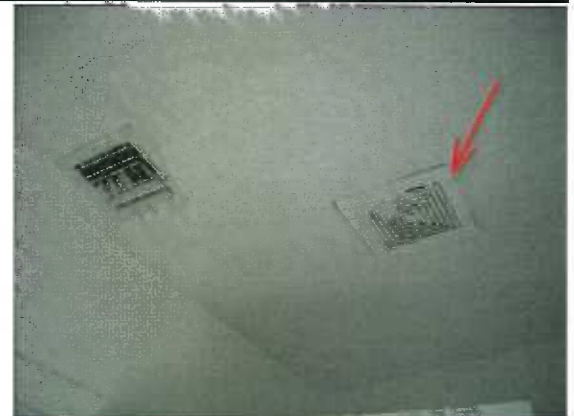
8. Main Level Powder Room Bathroom Ceiling: Drywall There is organic growth on the ceiling drywall.

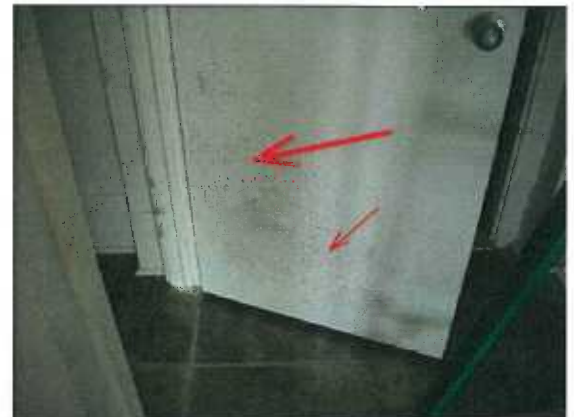
9. Ground Level Utility/Storage Room Living Space Doors: Painted, Flush Solid Core There is organic growth on the surface of the door.
10. Ground Level Entry Living Space Closet: Single There are signs of organic growth on the closet door.

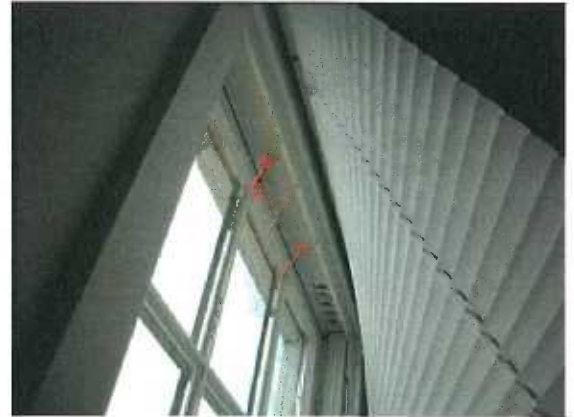
11. Stair Well Living Space Windows: Andersen, Double Hung, Tilt and Wash The center window in the stairwell, There are stains on the header piece of vinyl.

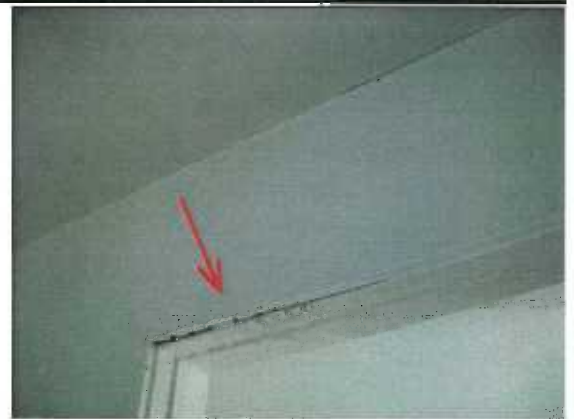
12. Main Level Laundry Room/Area Doors: Painted, Flush Solid Core The door trim has become loose on the inside of the laundry room door.
